Training on mercury management and remediation of contaminated sites

"La Soterraña" mercury mine characterization and restoration design.

Almadén (Spain) 18-19th November 2015

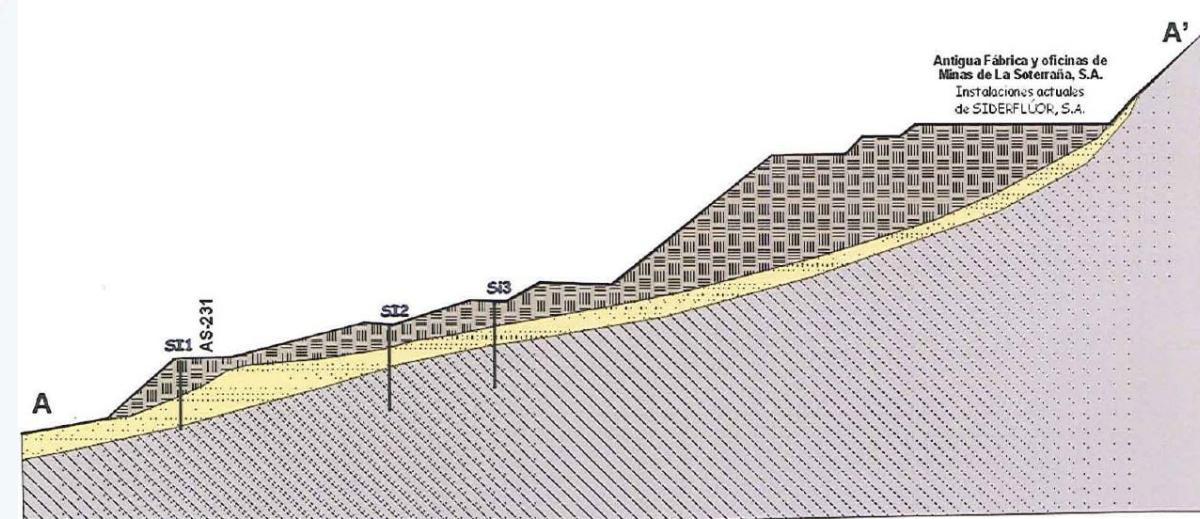
Lythological Cross Section

Mine waste and slag (dump) Clay and silt colluvium

Shale, limestone and sandstone alternation

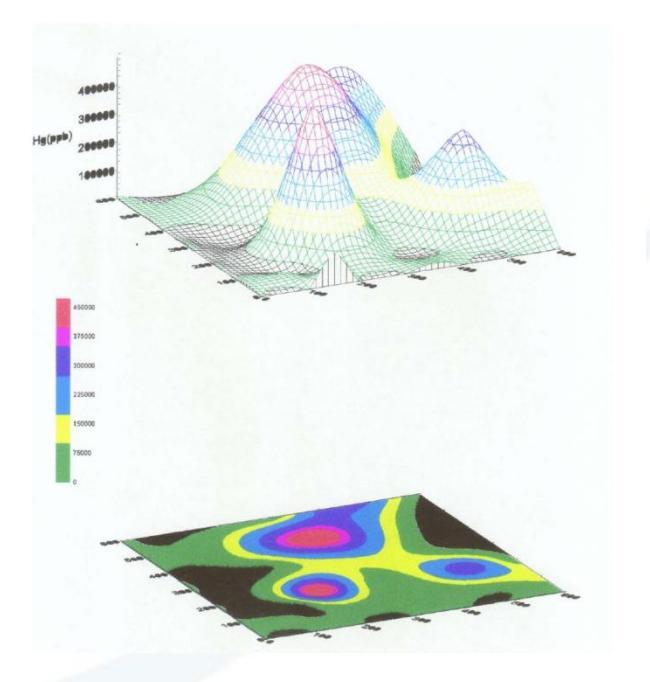
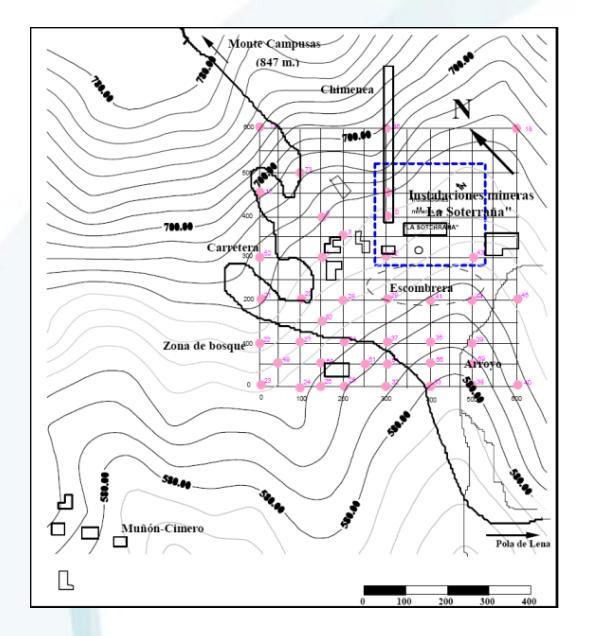
Hg in surface soils (µg/kg)

Systematic - orientated sampling grid.

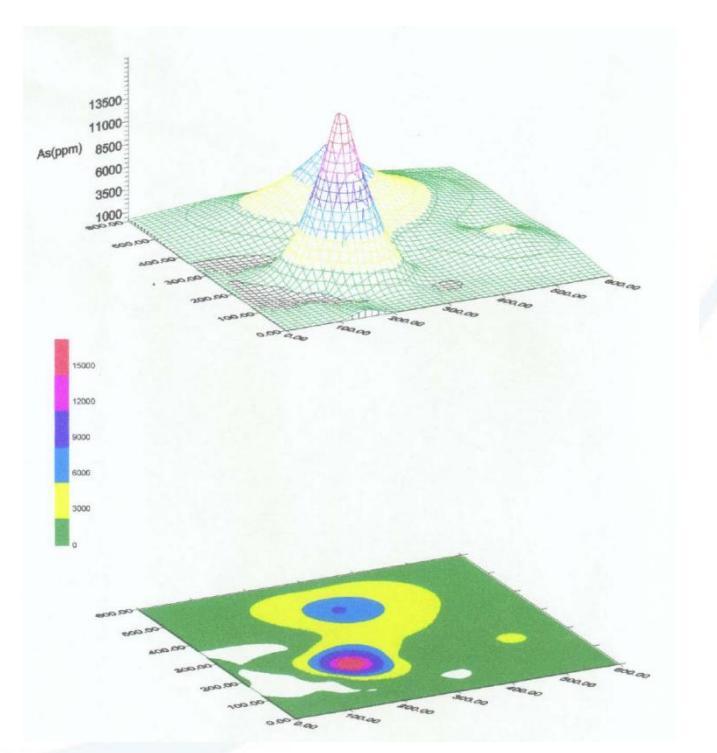
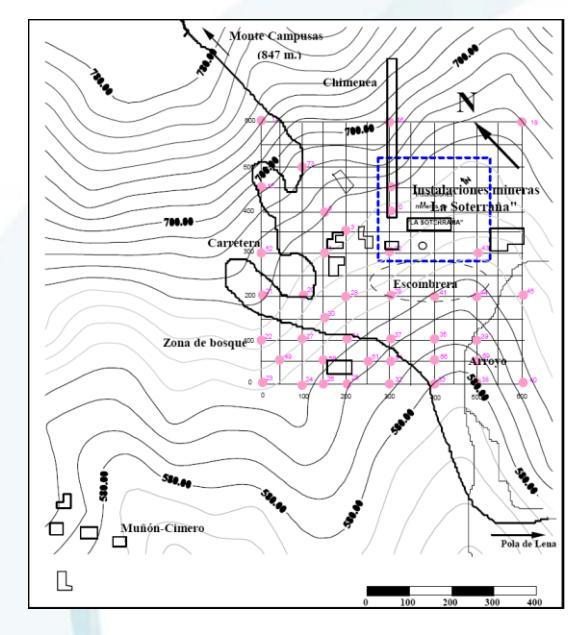
As in surface soils (mg/kg)

Systematic - orientated sampling grid.

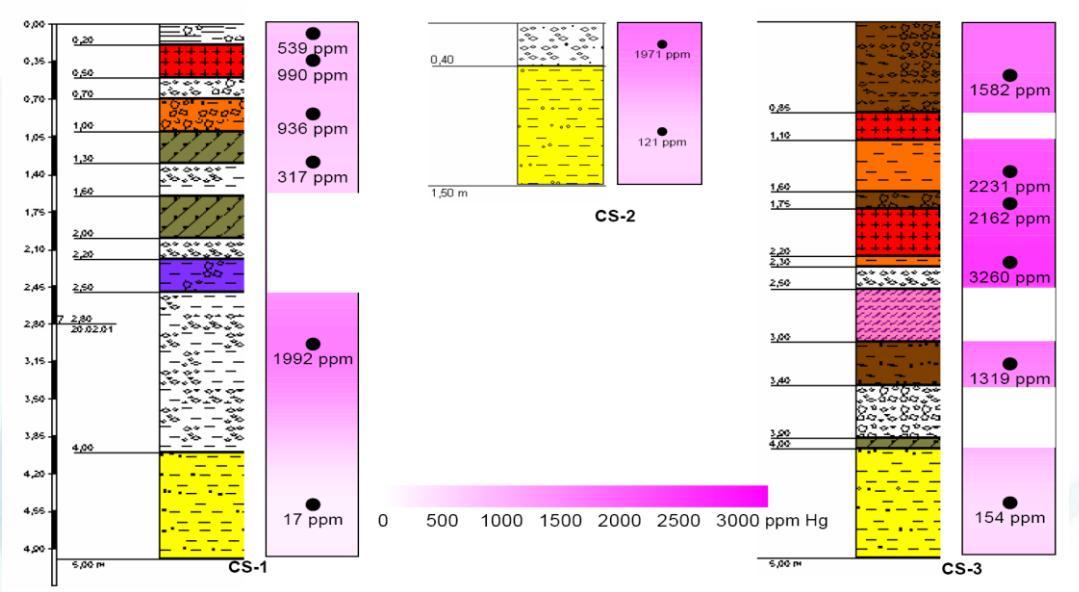
Vertical pollution percolation

Clay and silt colluvion play the role of vertical barrier (K = 10^{-7} to 10^{-9} m/s)

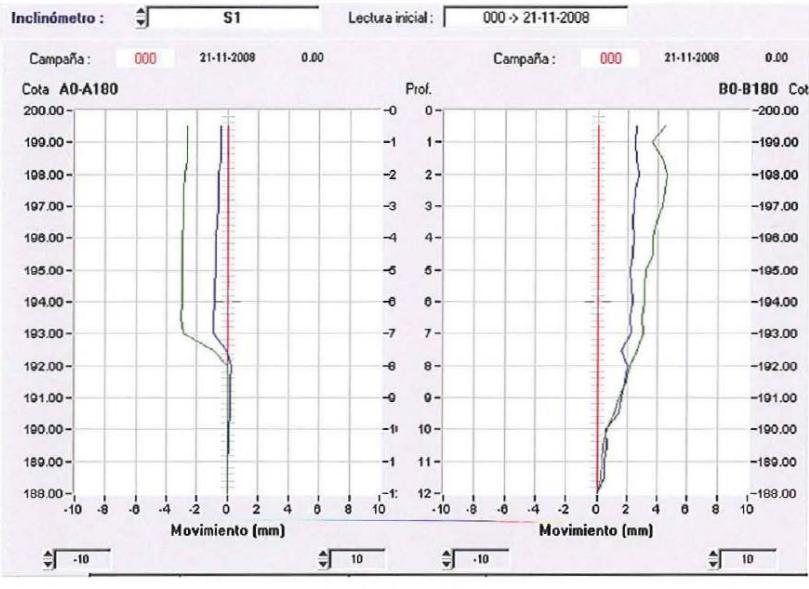
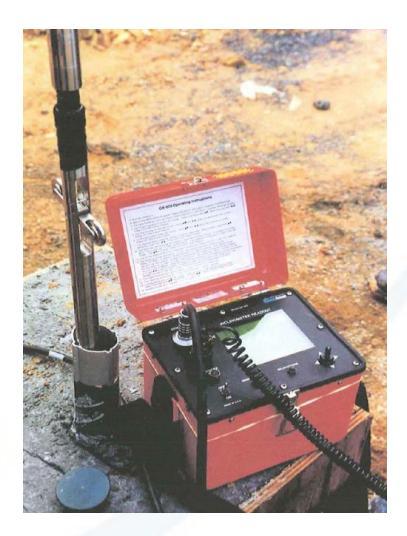
Dump mechanical estability

✓ Slide plane at 6-8 m under mine waste dump front.

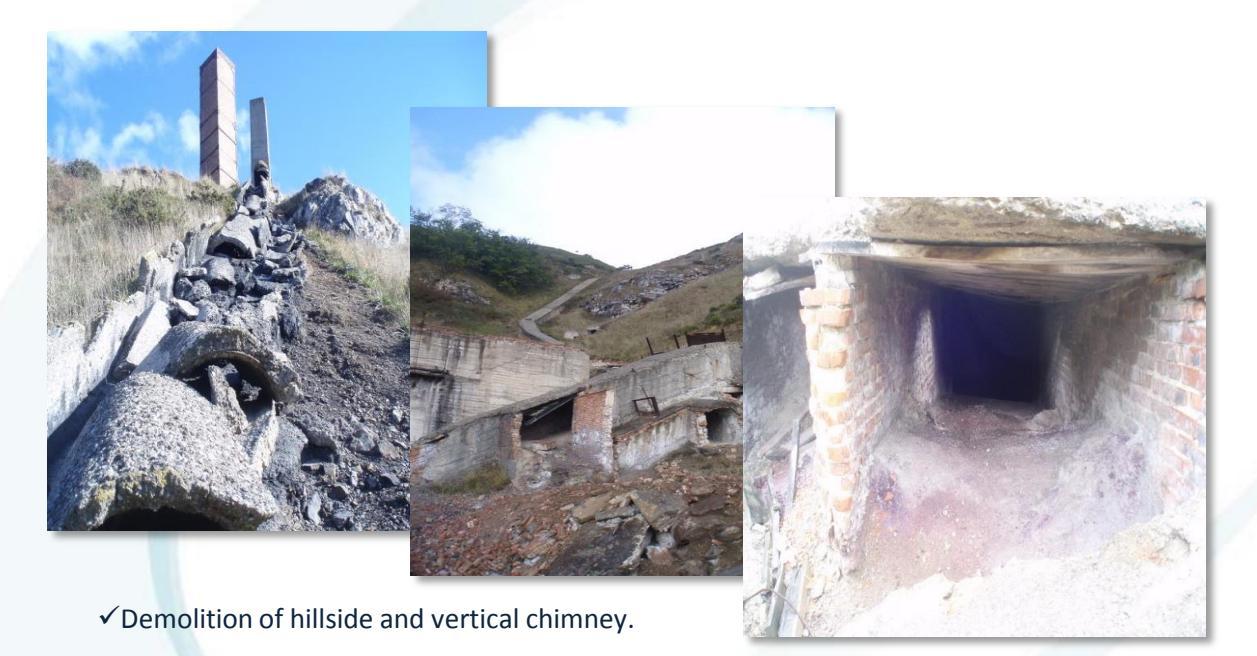
Phase 1- Decommission of mining facilities

Inside particles and surroundings soils with high concentrations of Hg and As.

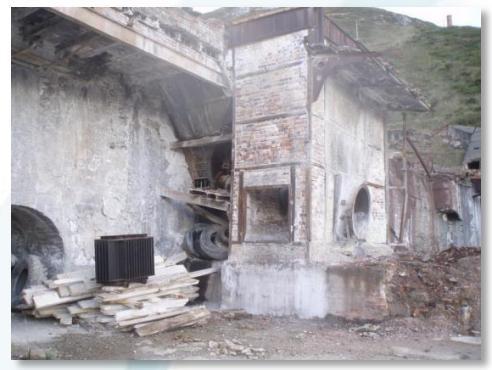
Transformer (PCBs).

Hazardous waste removal and external elimination.

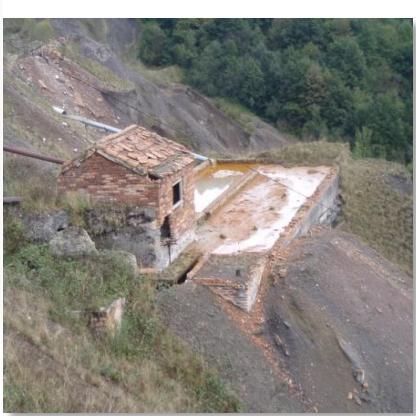
Tailing/sludge pond.

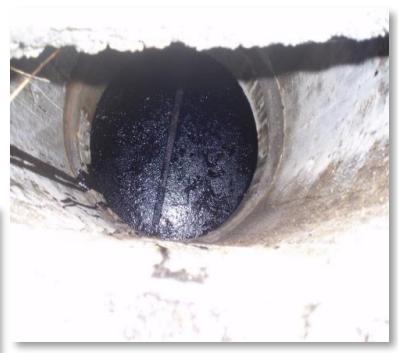
Fuel-oil in UST.

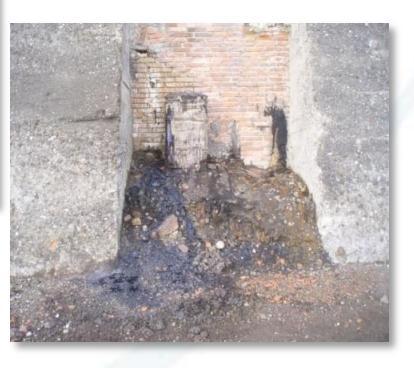
Fuel-oil filtrations in retaining wall.
