Training on mercury management and remediation of contaminated sites

"Reconditioning of the "Cerco de San Teodoro" slag heap. Minas de Almadén (Ciudad Real, Spain)" Almadén, Spain, 18-19 November 2015

Javier CARRASCO Minas de Almadén y Arrayanes S.A. Industrial Activities Manager jcarrasco@ctndm.es

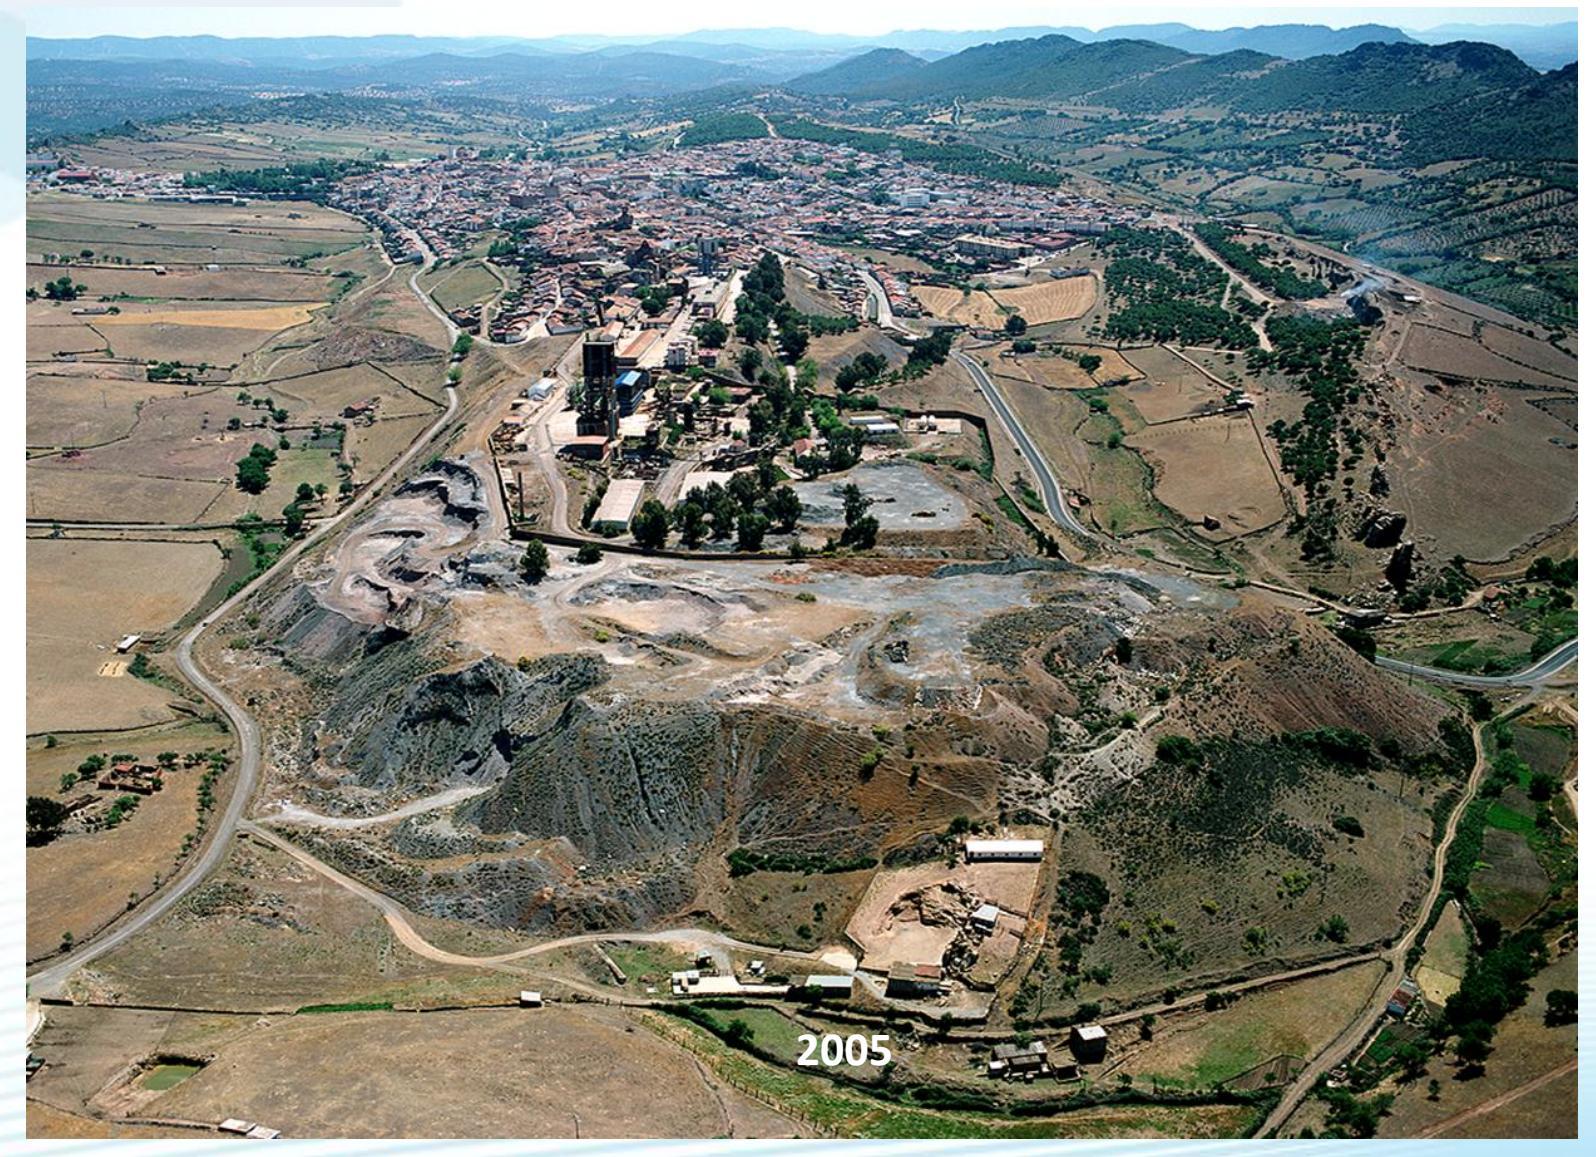
This waste heap contains deposits of waste from the mining operations as well as slag from the metallurgical processes accumulated through the centuries.

The volume of the waste heap is at present close to 3,5 million tons, covering 10 hectares

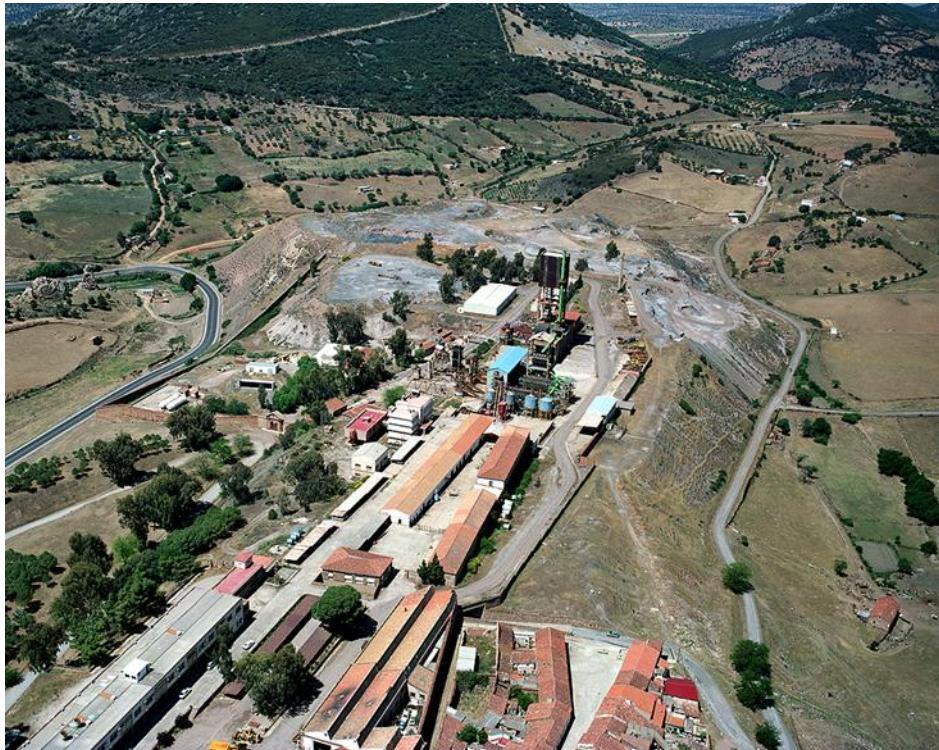
DUMP GEOMETRIC CHARACTERISTIC

OCCUPIED AREA (ha)	9.1
TOP AREA (ha)	4,9
SLOPE AREA (ha)	4,2
WASTE AMOUNT (t)	3,500,000
MAXIMUM HEIGHT (m)	58,7
MEDIUM SLOPE ANGLE	36º
PERIMETER (m)	865

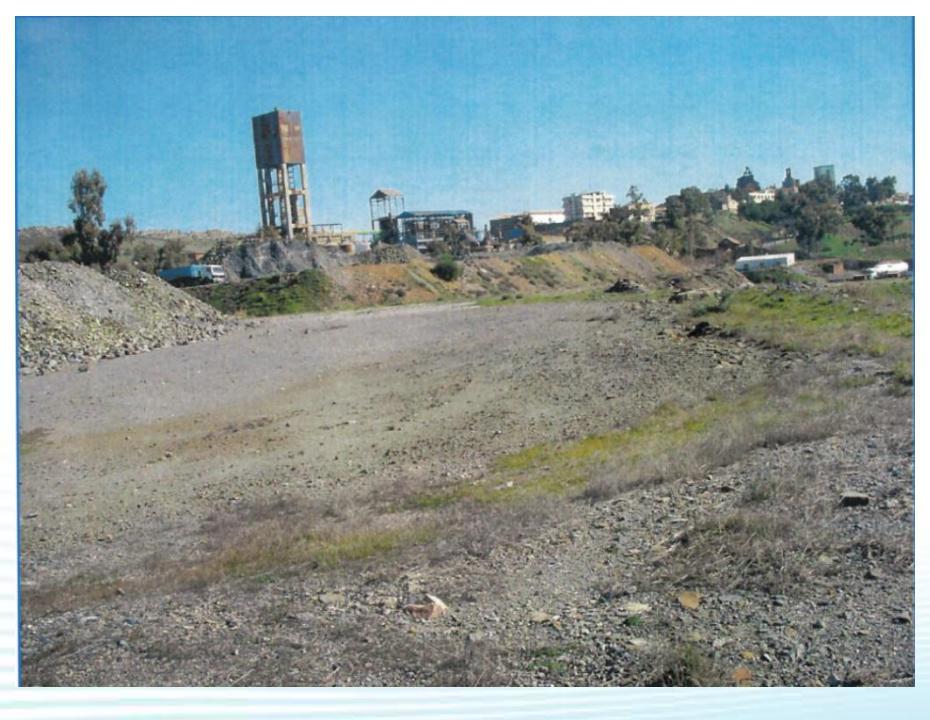
• ATMOSPHERIC CONTAMINATION Resuspension of dust downwind and mercury evaporation from the dump surface

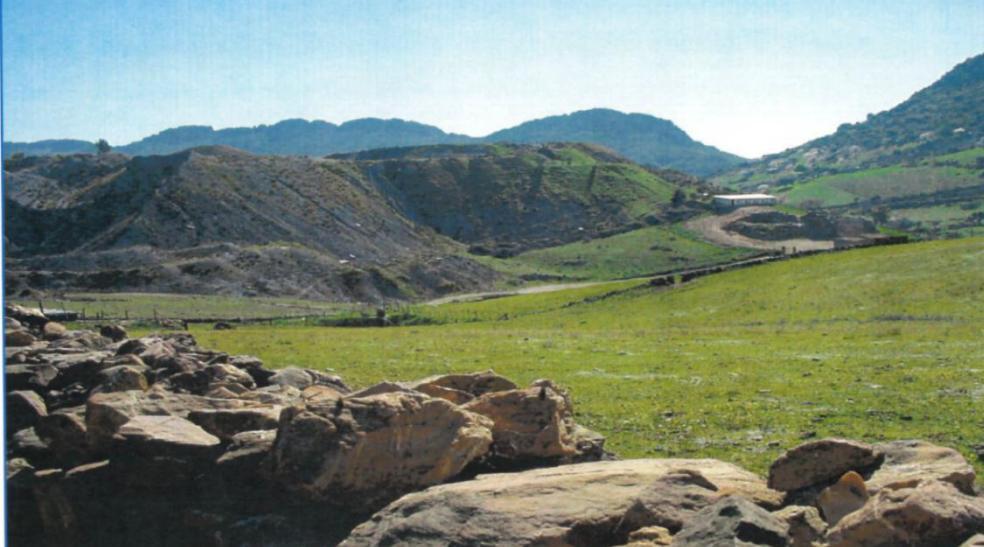
- HYDROGEOLOGIC CONTAMINATION
- ATMOSPHERIC CONTAMINATION
- GROUND OCCUPATION
- Environmental effect irreversible
- **Contamination** of nearby **lands** by dust dispersion

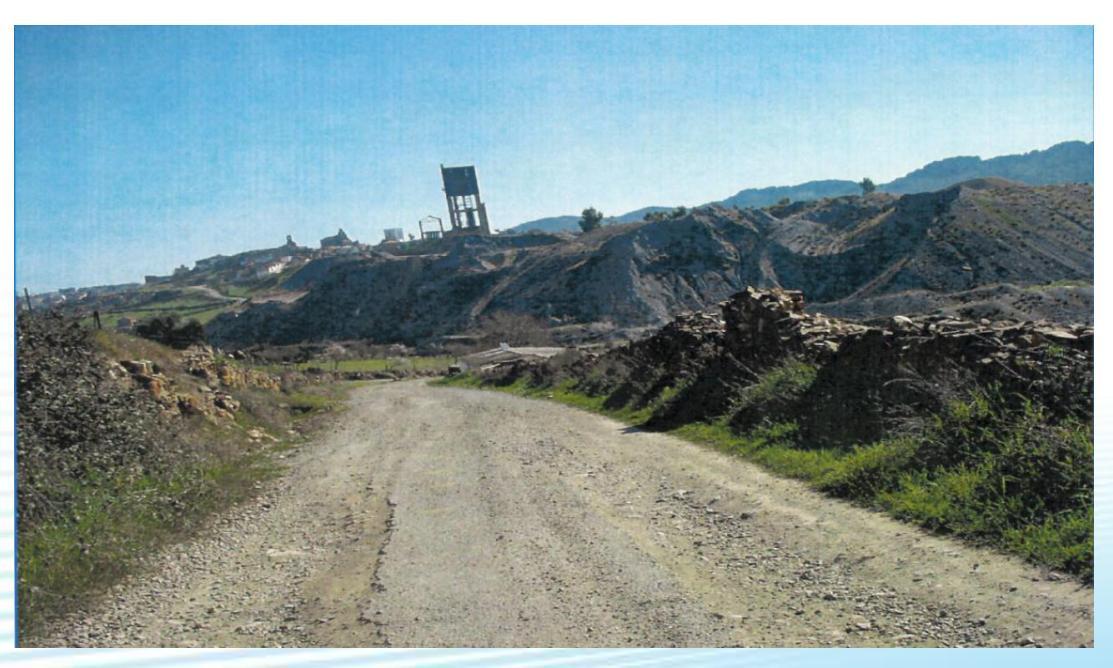
- HYDROGEOLOGIC CONTAMINATION
- ATMOSPHERIC CONTAMINATION
- GROUND OCCUPATION
- **GEOTECHNICAL RISKS** High risk of **landslide** and **rock falls**

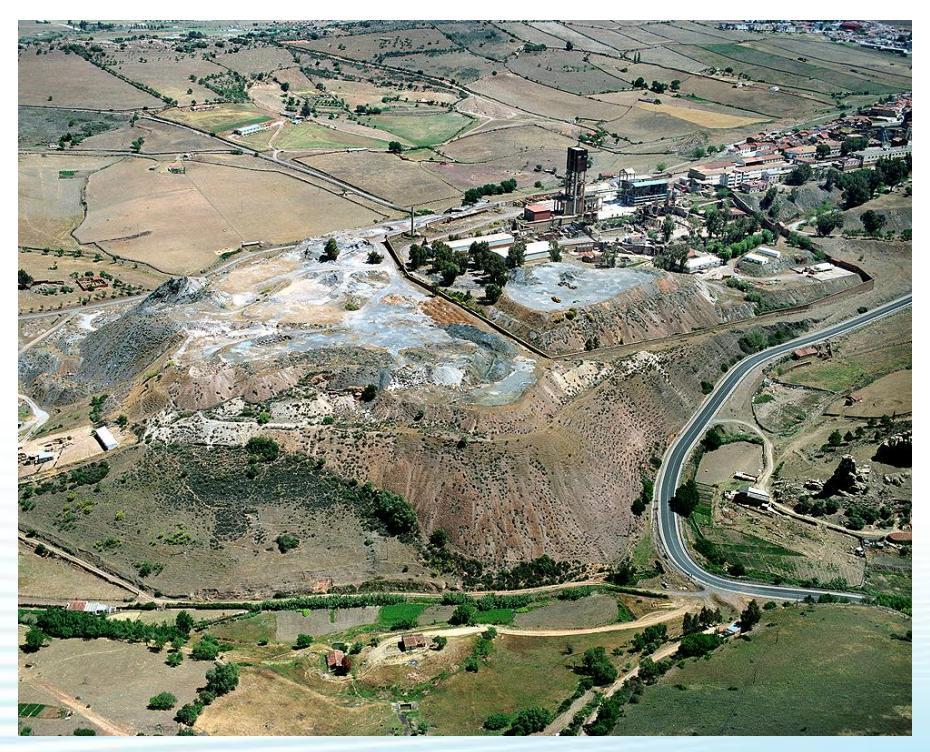
• **MORPHOLOGY AND LANDSCAPE** Modification of visual and chromatic landscape

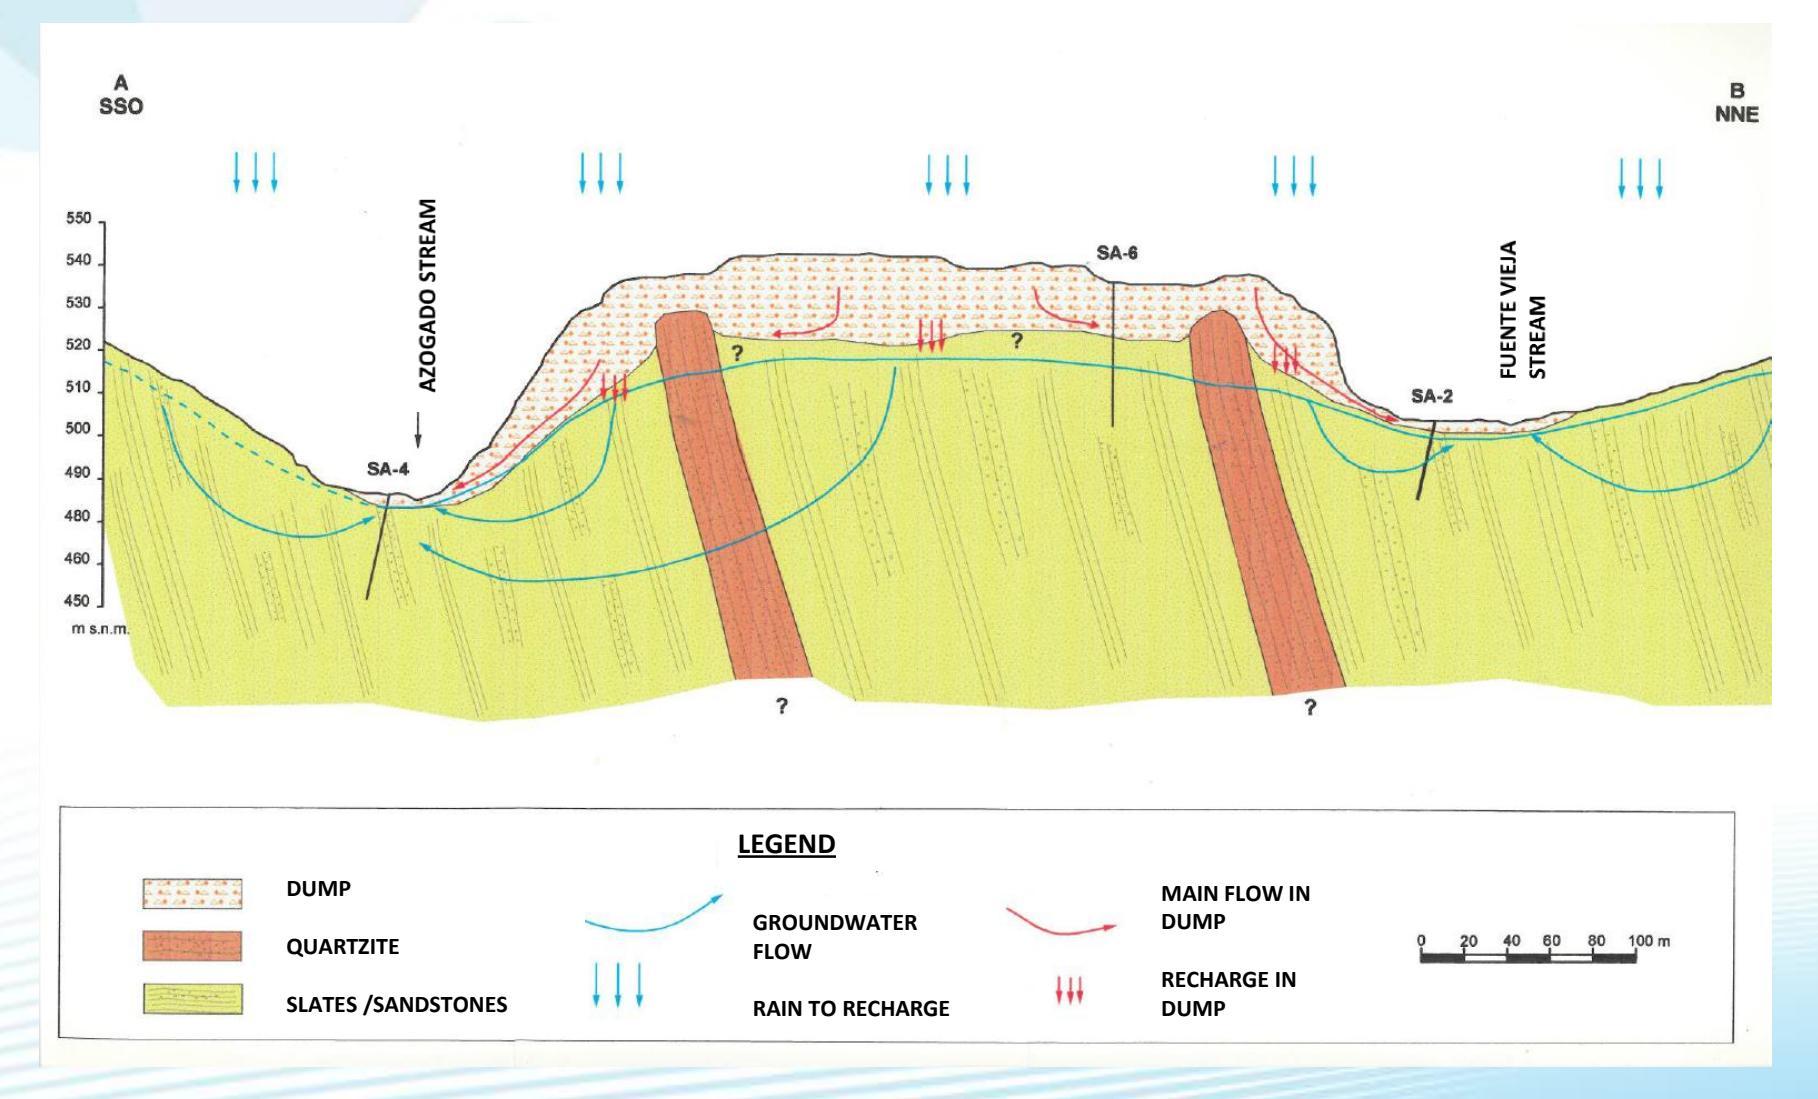
CHARACTERIZATION OF SURFACE WATER ALMADEN DUMP FUENTE VIEJA STREAM Parque Minero de Almadén **River network:** little flow and low slope. AZOGADO STREAM Conditioned by climate In summer, intermittent flow VALDEAZOGUES RIVER

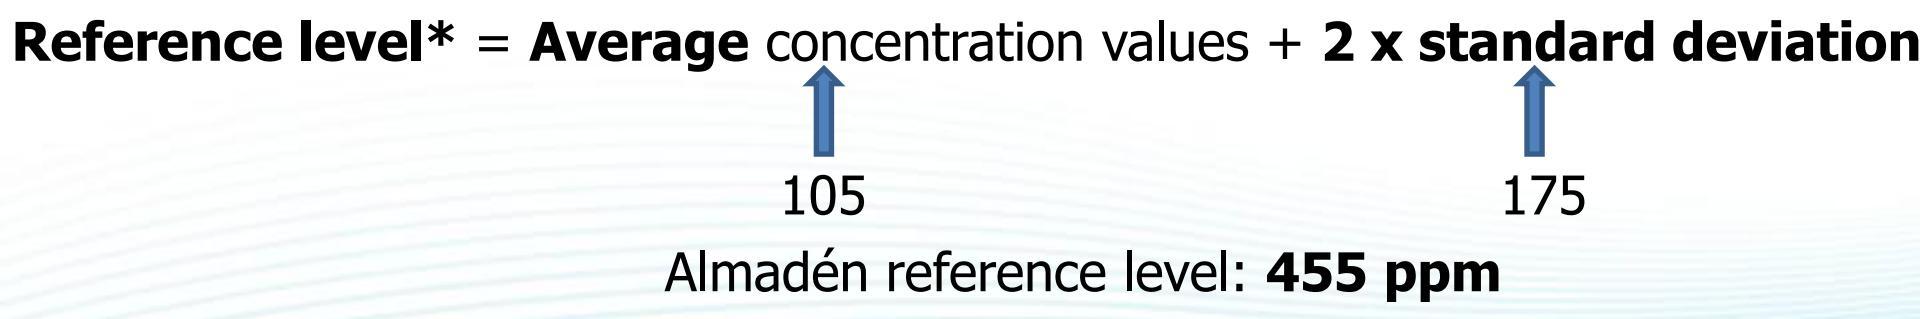
To define the **acceptable concentration** limit for mercury in soil:

- Samples need to be taken at points in the environment at which it can be guaranteed that there is no contamination.
- These sampling points must have **geological substrates** with **similar** characteristics to those in the contaminated site.
- Under these conditions:

*According **Royal Decree 9/2005** of 14 January, which set the relationship of activities potentially contaminating soil and criteria and standards for the declaration of contaminated soils.

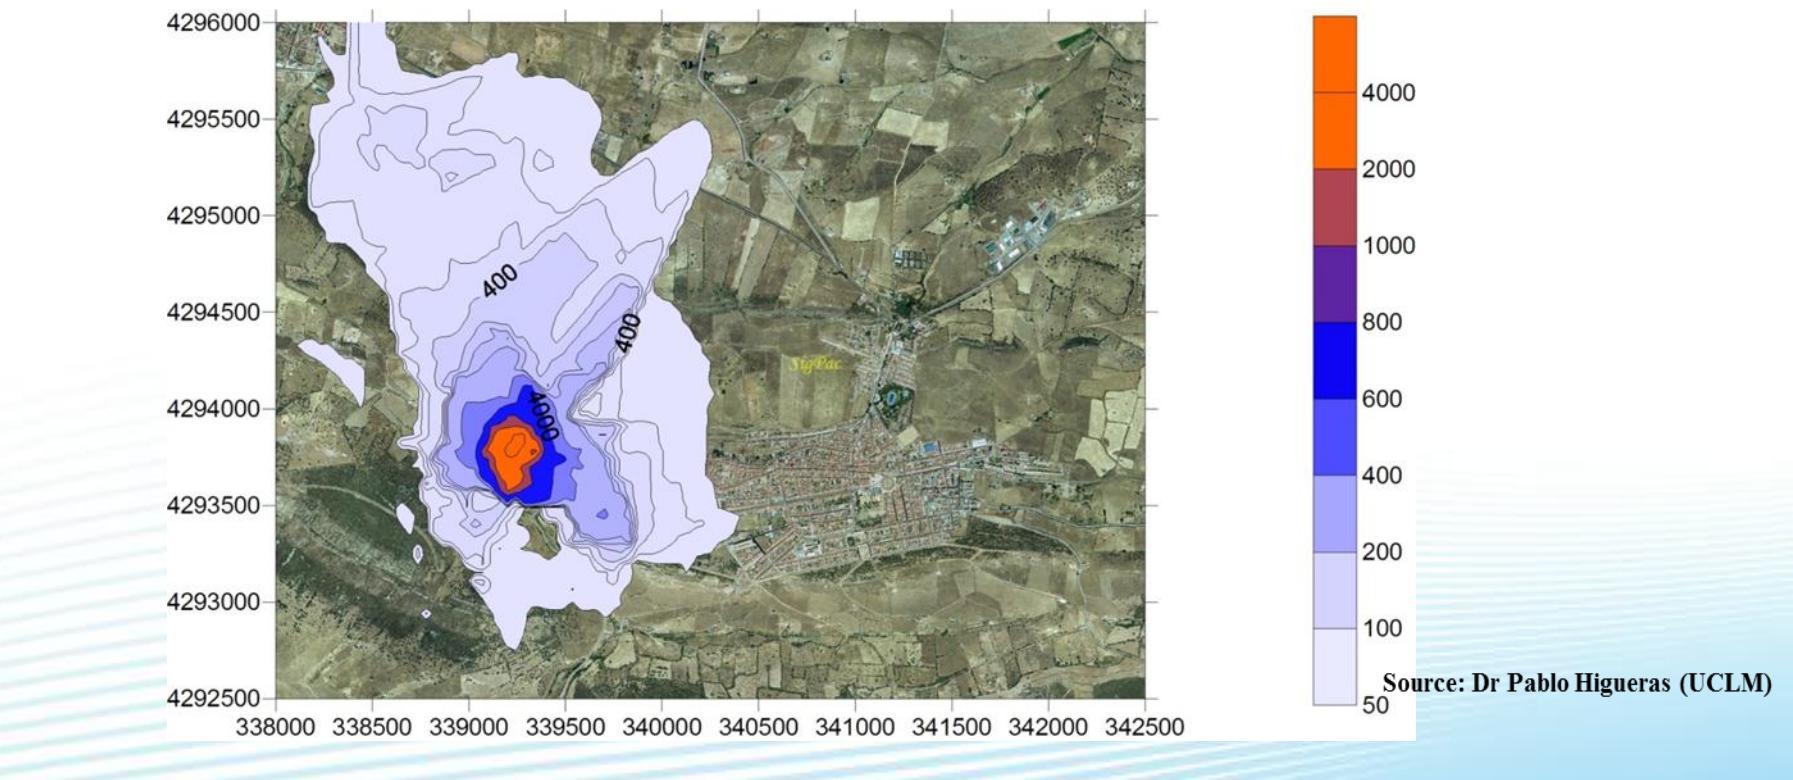
CHARACTERIZATION OF AIR

Reference concentration of mercury in air:

1000 ng/m³ annual average (WHO Air Quality Guideline for Europe)

300 ng/m³ reference concentration in residential areas (United States Environmental Protection Agency (EPA))

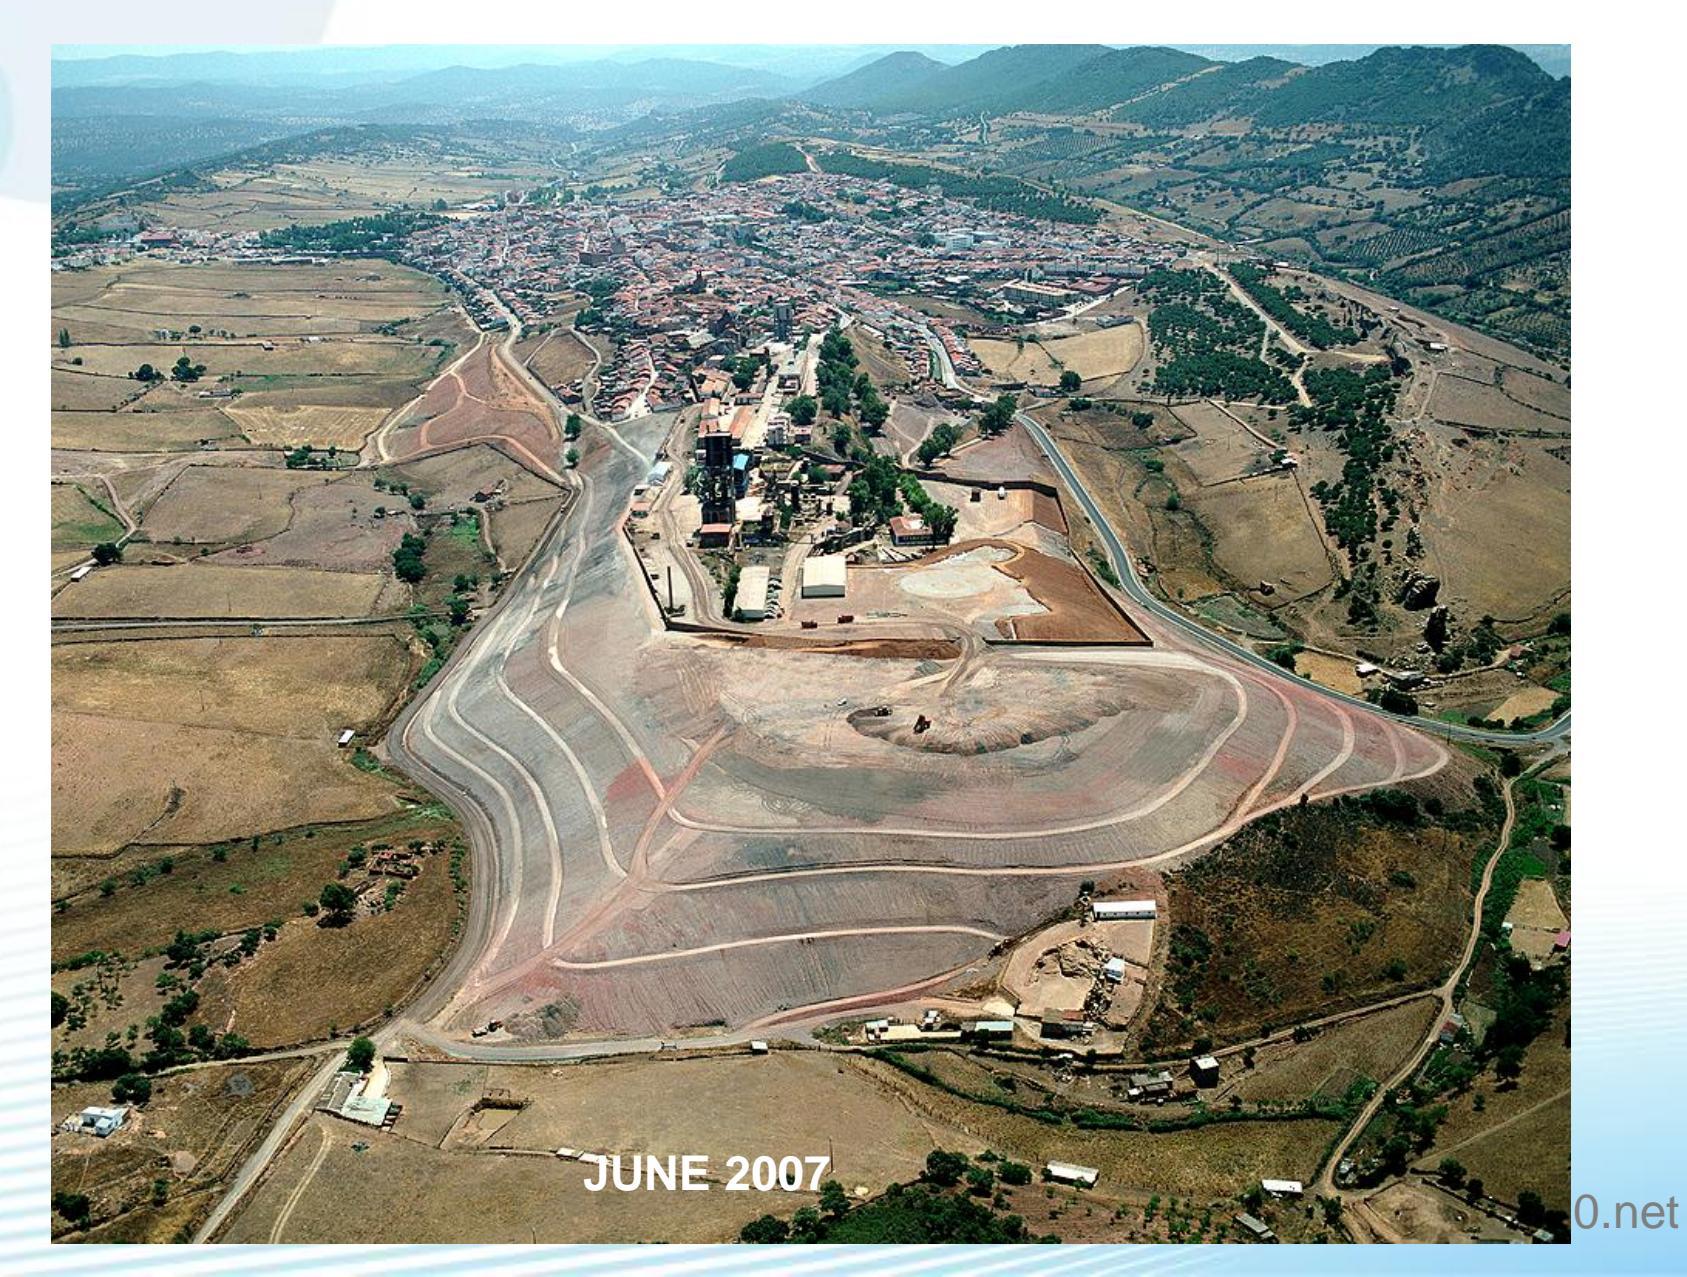
PHASES 1. DUMP FORMING

• Remodel the slopes and the capping plate of the dump

Stabilizing their conditions

Earth filling of 493,582 m3 of material

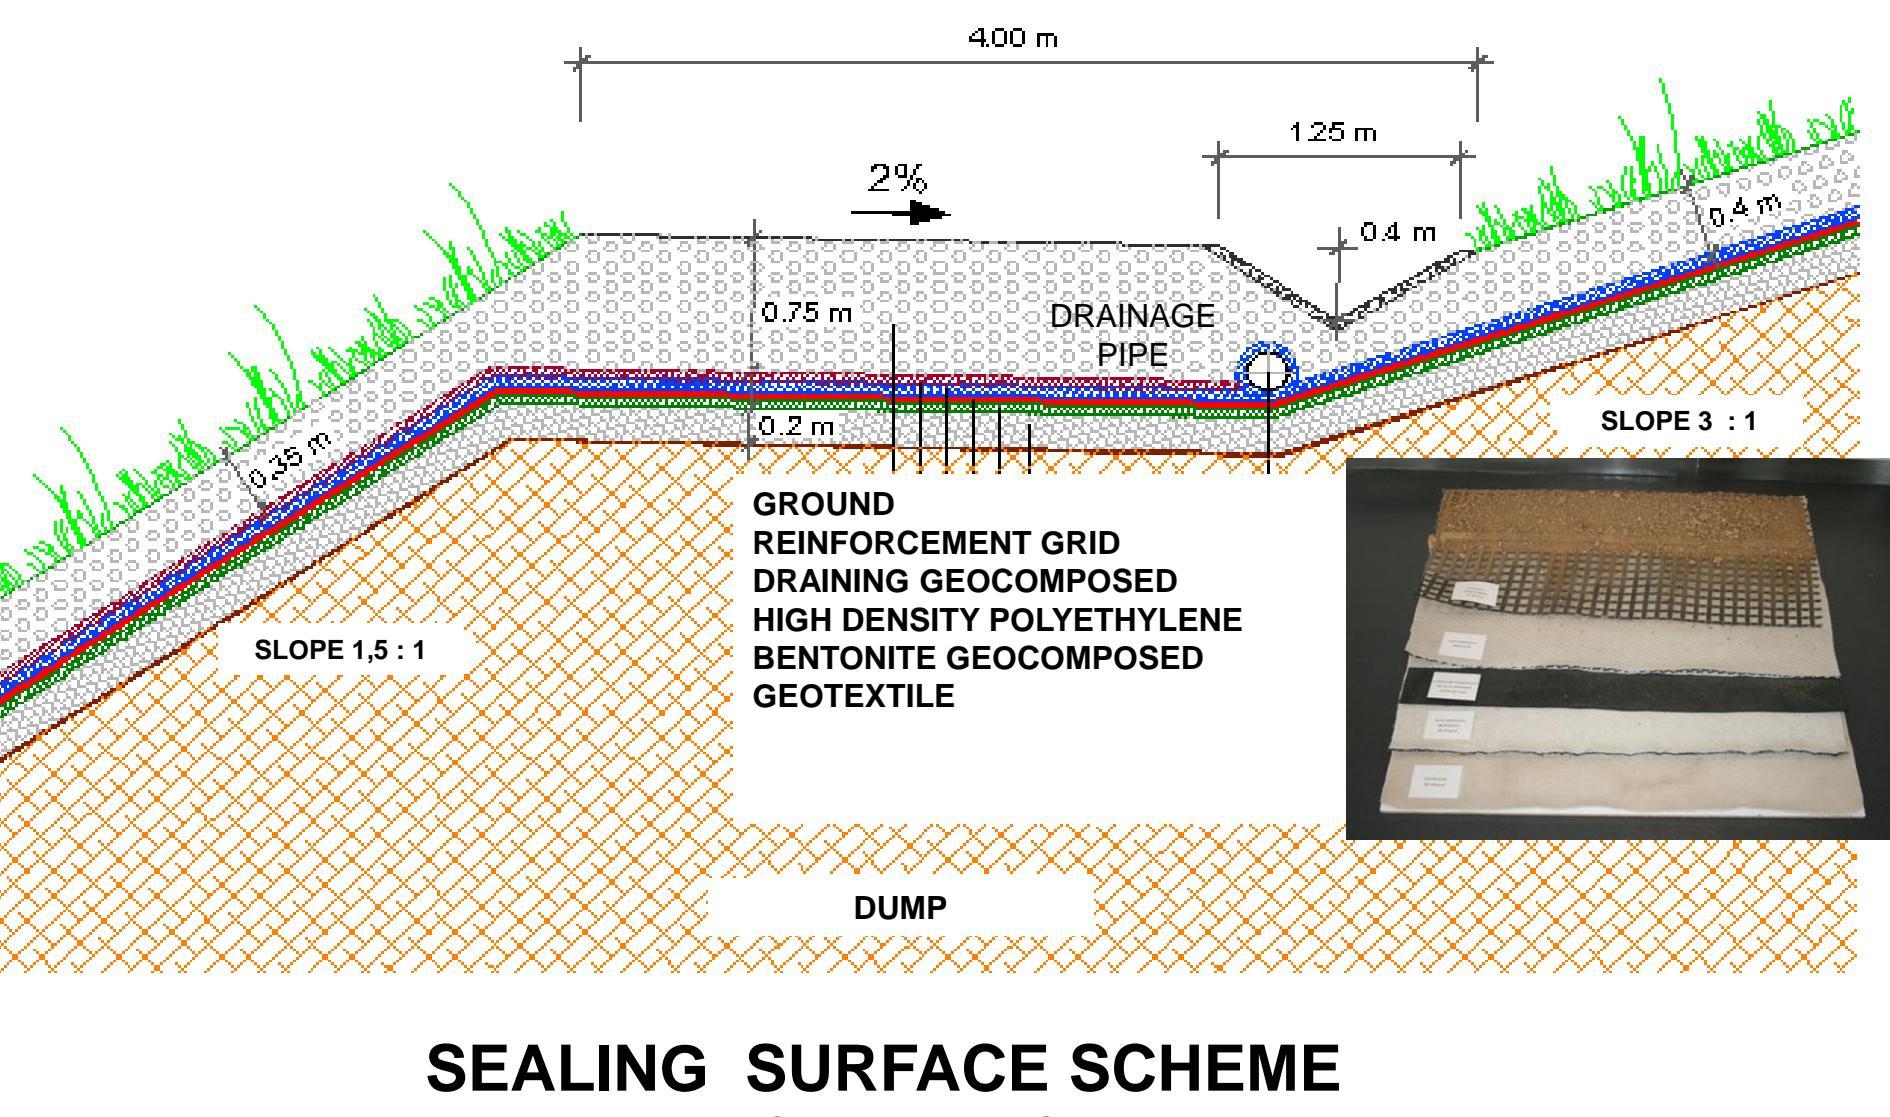
LOW INCLINATION SLOPE

2. DUMP SEALING:
Functions:
To prevent the entrance of water in the dump, avoiding the generation of leachate and the material dispersion.

Insulation, avoiding mercury evaporation in the dump ace

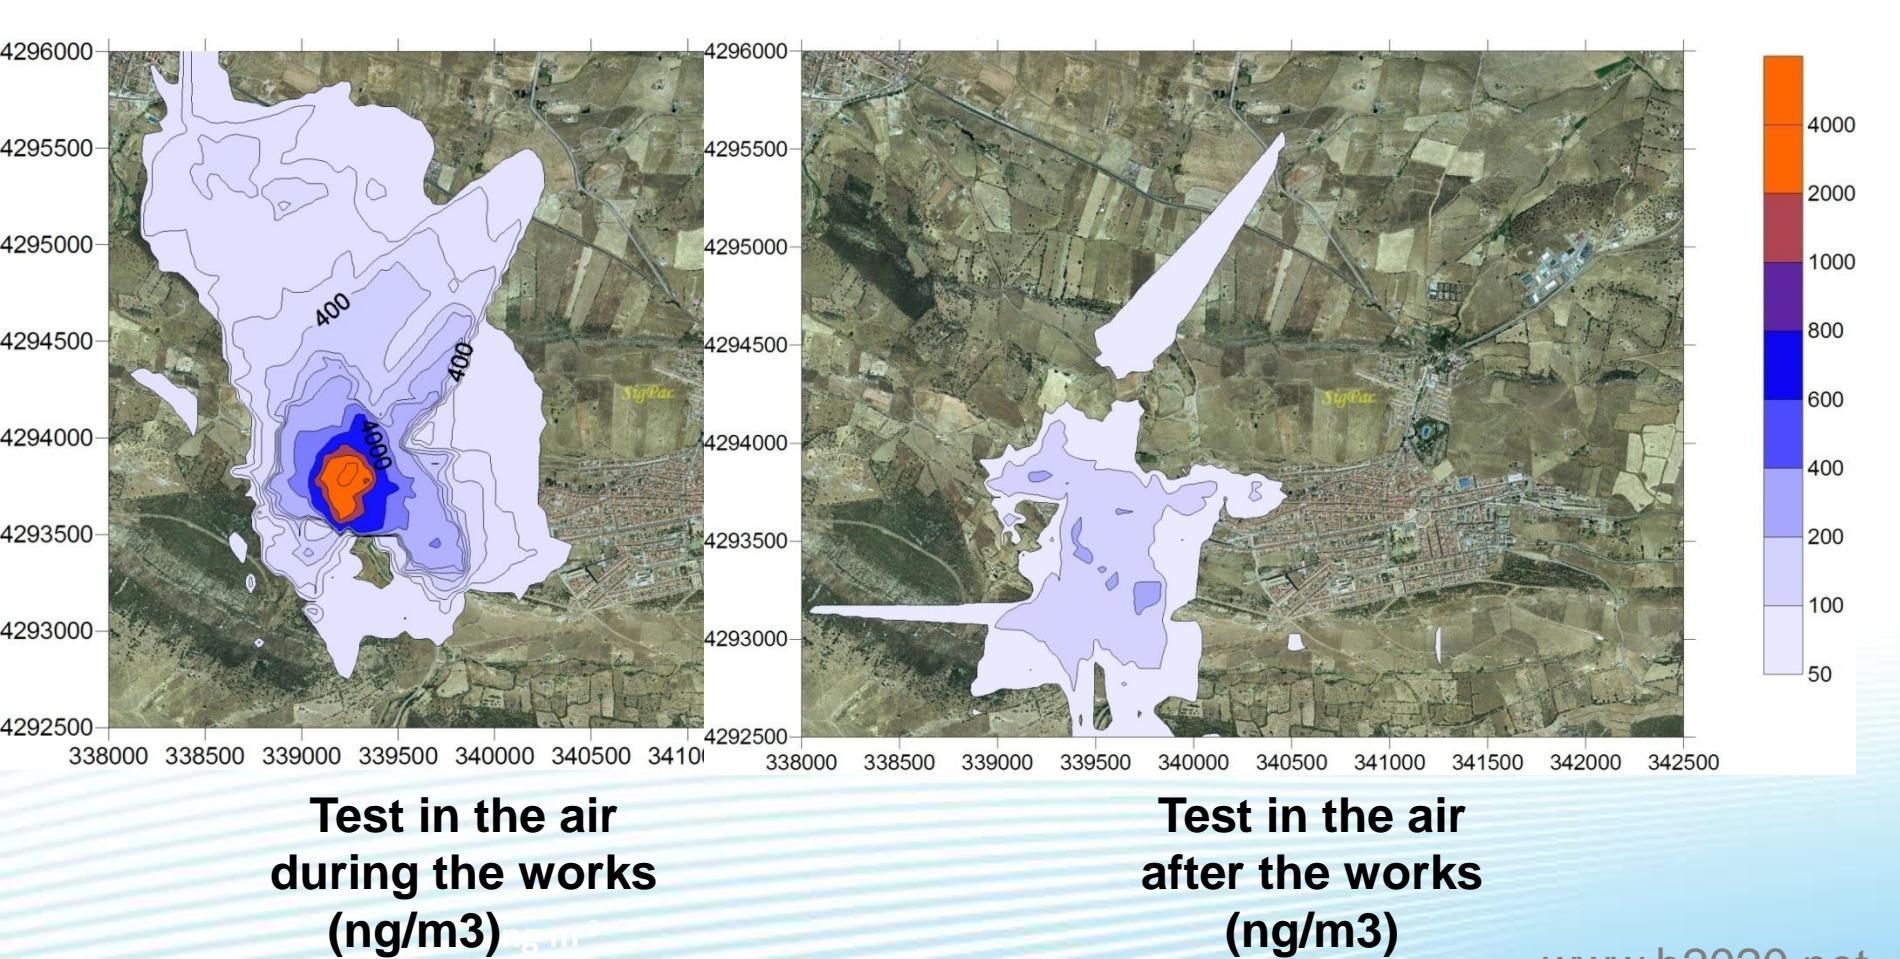
RESTORATION OF THE WASTE HEAP IN THE SAN TEODORO ENCLOSURE The first results: Emission to the atmosphere

Source: Dr Pablo Higueras (UCEM)
