Pollution prevention case studies

Recovery of final product and improved cleaning processes

Company background	HIPERTIN, S.A. (Barberà del Vallès, Spain)
Industrial sector	Chemical. Cosmetics manufacture (production of peroxide hair dye).
Environmental considerations	<p>In the case of this company, the reactors where the dye phases were mixed (which had a conical bottom) were shut down and emptied out once the mixing was done. However, there was some residue left on the bottom of the reactor. Before having them cleaned, they were left open for one day. Due to the characteristics of the oxygenated dyestuff, contact with the air promoted fast oxidation and hardening of the product. As a result, a huge amount of water was required for cleaning. Because of the oxidation and the location of the washout valve, 3 kg of finished product were lost as wastewater in every cleaning operation and for each reactor.</p> <p>In addition, refrigeration of reactors necessary throughout the dye manufacturing process, was achieved by means of an inside-cooling coil, which was connected to an open water circuit.</p>

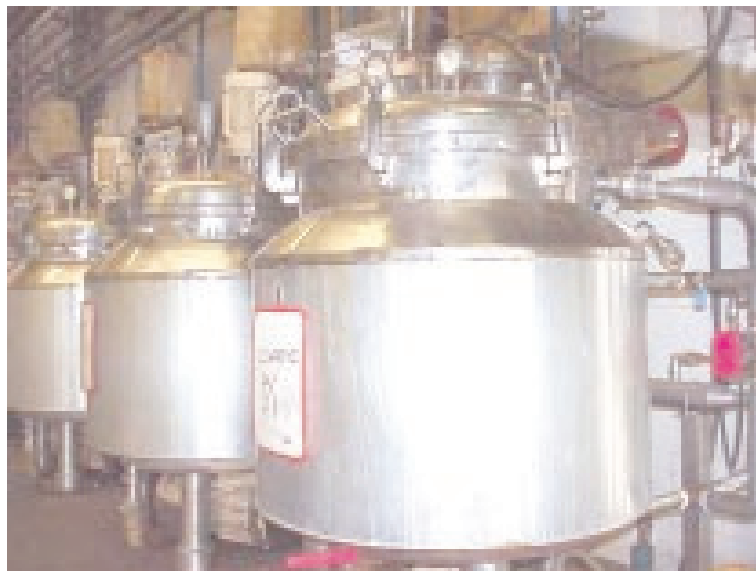
Reactors where dyes are mixed
