No. 57

Pollution prevention case studies

Recycling of polypropylene waste

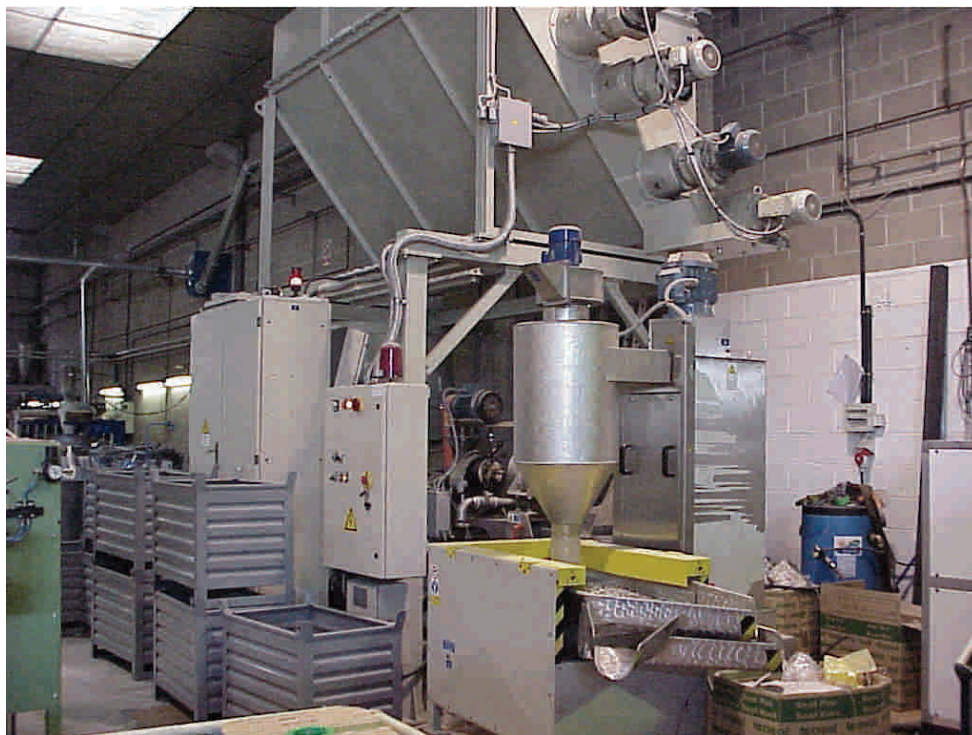
Photograph of the installation

Background	<p>During the manufacture process, TECSEAL, SA generated polypropylene waste from the production of weathertight seals, which was recovered as a by-product. The amount of waste generated in the year 2000 was 64 t, and the forecast for 2001, the year in which the actions were carried out, was of 70.5 t.</p> <p>The objective of the company was to:</p> <ul style="list-style-type: none"> • Reduce waste generation at source. • Save on the purchase of raw material.
Summary of actions	<p>Actions consisted of installing a polypropylene waste extrusion and grinding system, in order to reuse the recycled surplus as raw material.</p> <p>With these actions it is possible to recover 100% of polypropylene waste, which can then be reused in the plastification operation, in specific proportions with regard to the virgin polypropylene.</p> <p>These actions included the following phases:</p> <ul style="list-style-type: none"> • Storage of polypropylene waste in a bin. • Force feeding of waste into the extruder. • Melting of waste. • Grinding of polypropylene in a mouth with rotating knives. • Cooling of regrind using water in a closed circuit. • Hot air drying of recycled polypropylene regrind. <p>This installation currently runs at a reuse cycle of 30 kg/hour, although it is designed for a capacity up to 100 kg/hour, to meet future requirements.</p>
