No. 49

Pollution prevention case studies

## Improvements in the cleaning system: the CIP system (clean in place)

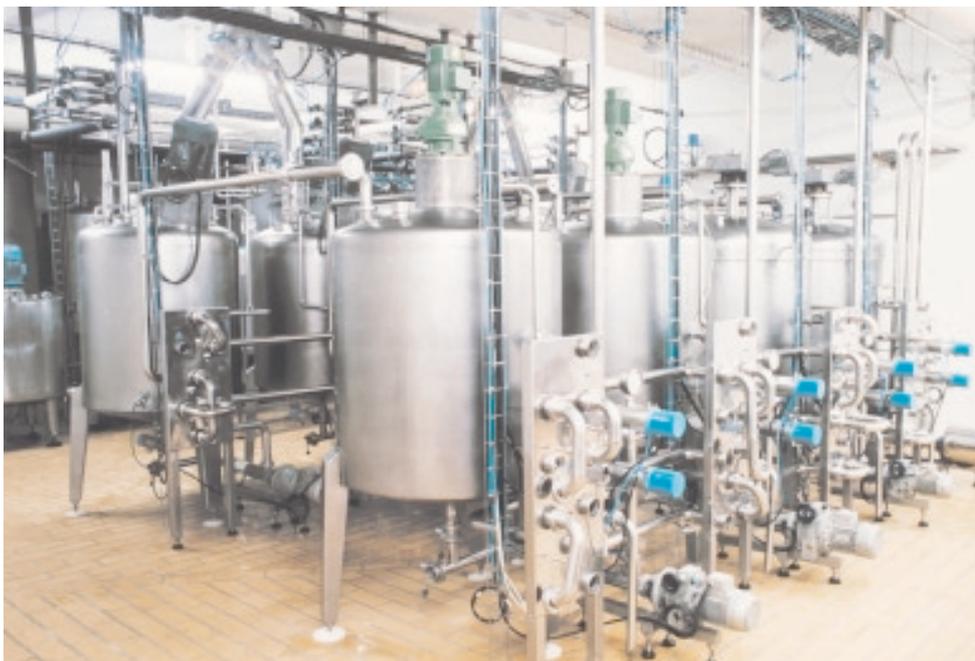
## Photography of the installation

*Cleaning system*

<b>Background</b>	<p>The company generated wastewater from cleaning the pipes and other operations of preparation of the batter. In 1997, works began, along with an increase of the productive capacity and a general restructuring of the factory, to rationalise the productive process. The performance was made taking into account the following premises:</p> <ul style="list-style-type: none"> <li>• To recover batter remains as far as possible.</li> <li>• To reduce the amount of water for cleaning the facilities.</li> <li>• To reduce to the organic load of wastewater and thus improve the quality of its discharges.</li> </ul>
<b>Summary of actions</b>	<p>The main objective of the project was the recovery of the batter remains and the reduction of the volume and the pollutant load of discharges, by means of installing a clean-in-place (CIP) system.</p> <p>The CIP is based on the following phases:</p> <ul style="list-style-type: none"> <li>• Dry-cleaning of the pipes, by means of driving a piston through them propelled by compressed air, so that the batter is recovered.</li> <li>• Rinsing with water, to drag out the batter remains of the pipe.</li> <li>• Recirculating a basic solution, to de-scale and sanitize the pipes.</li> <li>• Final washing with clean water.</li> </ul> <p>The use of this system has been accompanied by the construction of a batter recovery tank and by the construction of pipes of transport free of obstacles.</p> <p>Furthermore, a wastewater treatment plant was installed based on three successive tanks for the separation of fats and the sedimentation of sludge, thus improving the quality of the wastewater released.</p>
